Manhole Inspection Summary

Manhole # S33U__001MH

Insp Date: **1/9/09 1:53 PM**

Location Address: **1403 race st**

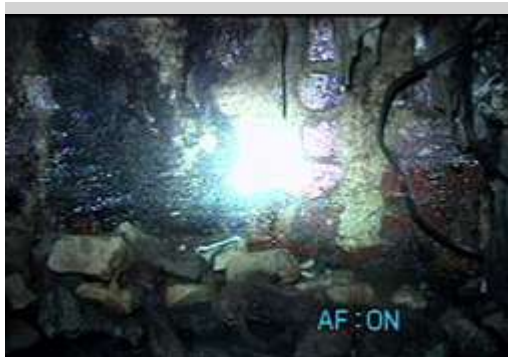
Defect 5

Condition: ☐ Sound ☐ Cracked ☐ Root Intrusion ☐ Deteriorated ☐ Leaks ☒ **Debris**

bench debris

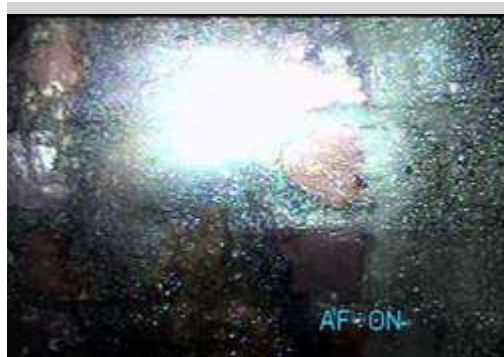
Defect 4

Infiltration: ☐ None ☐ Joint ☐ Cracks ☐ Mortar ☐ Roots ☒ **Wall**

barrel infiltration at wall

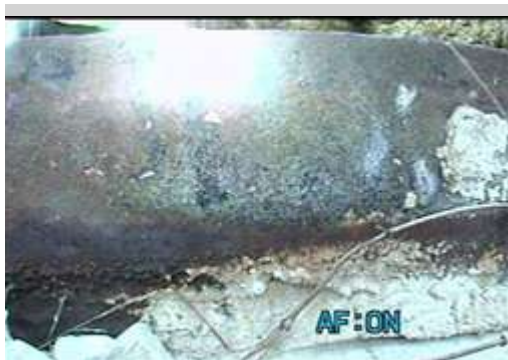
Defect 3

Cover Shape: **Circular** Diameter: **32** (in.) Length: **0** (in.) Dist A/B Grade: **6** (in.)

cover above grade 6 inches

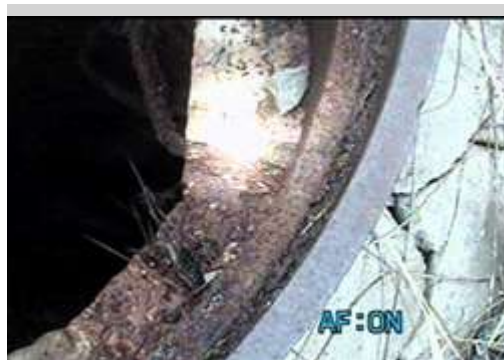
Defect 2

Frame Offset: **4** (in.) Condition: ☒ Sound ☐ Cracked ☐ Leaks

offset

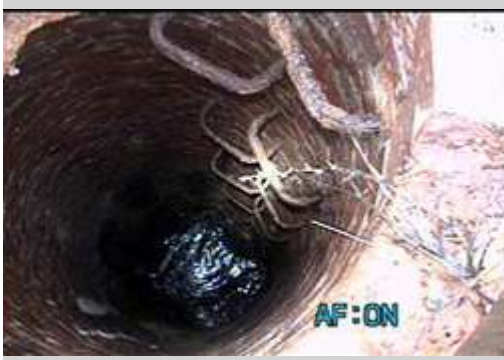
Defect 1

Steps Count: **14** Missing: **0** ☒ **Corroded**

steps corroded

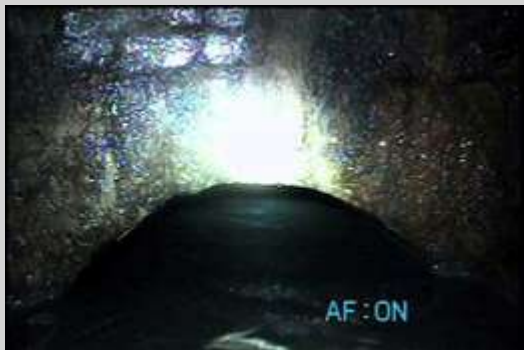
12 O'Clock Outflow

27 in. Circular Gravity Sewer
Pipe Out @ 12 O'Clock

Invert Depth: **20.66** (ft.) Flow Characteristics: **Fast**

Infiltration: **None** Pipe Seal Cond: **Unknown**

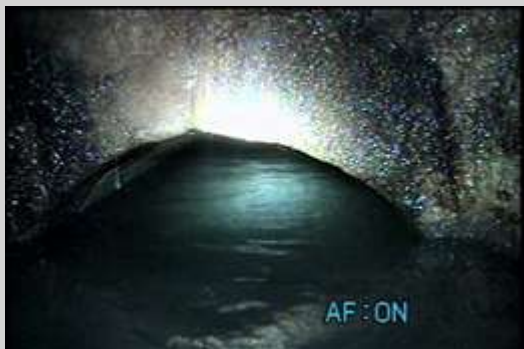
6 O'Clock Inflow

27 in. Circular Gravity Sewer
Pipe In @ 6 O'Clock

Invert Depth: **20.33** (ft.) Flow Characteristics: **Fast**

Infiltration: **None** Pipe Seal Cond: **Unknown**
